GigaDevice Semiconductor Inc.

Device limitations of GD32E10x&C10x

Errata Sheet

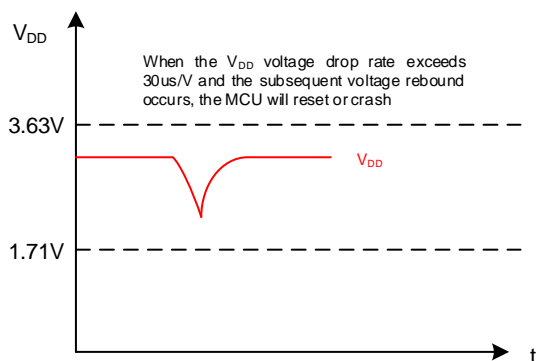
2.2.2. Rapid drop and then rebound on V_{DD} will cause the MCU to crash or reset

When the V_{DD} drop rate exceeds $30\mu\text{s/V}$ (for example, V_{DD} drops from 3.63V to 1.71V at a rate of $25\mu\text{s/V}$) and then V_{DD} voltage rebound, the MCU will crash or reset.

For example, when the MCU operates at V_{DD} , the V_{DD} voltage drops due to the CMOS power transistor being turned on, and then the subsequent capacitor charging restores the V_{DD} voltage.

Ensure that the V_{DD} drop rate does not exceed $30\mu\text{s/V}$ in the PCB design.
