**GigaDevice Semiconductor Inc.**

**Device limitations of GD32E50x**

## **Errata Sheet**

Revision 1.6

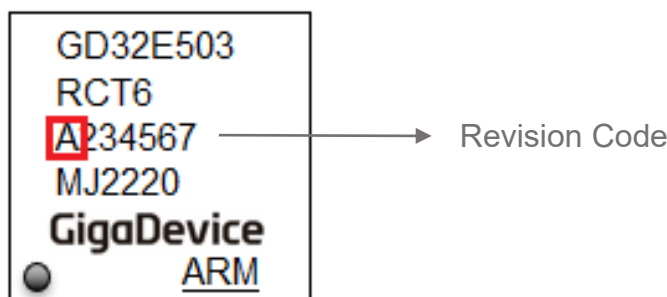
**Figure 1-1. Device revision code of GD32E50x**

The device revision can be determined by the mark on the top of the package. The 1st code on the line 3 of the mark represents product revision code. As the picture shown in [Figure 1-1. Device revision code of GD32E50x](#).
