GigaDevice Semiconductor Inc.

Device Limitations of GD32A513

Errata Sheet

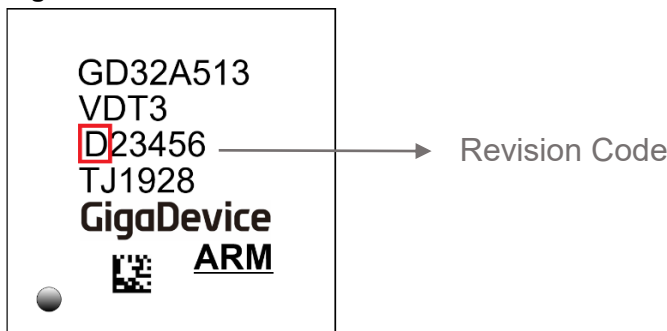
Figure 1-1. Device revision code of GD32A513

The device revision can be identified according to the mark on the top of the package. The 1st code on Line 3 of the mark is the product revision code, as shown in [Figure 1-1. Device revision code of GD32A513](#).
