GigaDevice Semiconductor Inc.

Device limitations of GD32G5x3

Errata Sheet

Revision 1.0

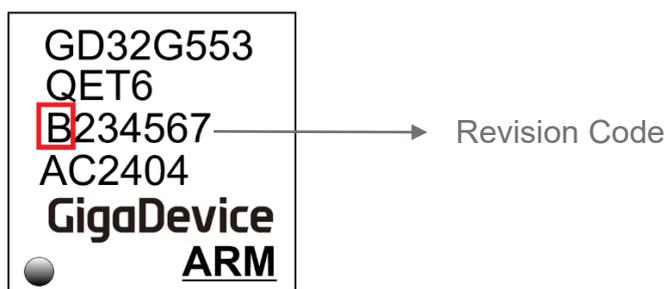
Figure 1-1. Device revision code of GD32G5x3

The device revision can be determined by the mark on the top of the package. The 1st code on the line 3 of the mark represents product revision code. As the picture shown in [Figure 1-1. Device revision code of GD32G5x3](#).
